Aircraft Accidents that Caused Major Changes to Emergency Response Equipment and Procedures

Mark T. Conroy

**Senior Fire Protection Engineer
National Fire Protection Association, USA**

**The International Forum on Emergency and Risk Management
Singapore Aviation Academy
10-12 January, 2005**

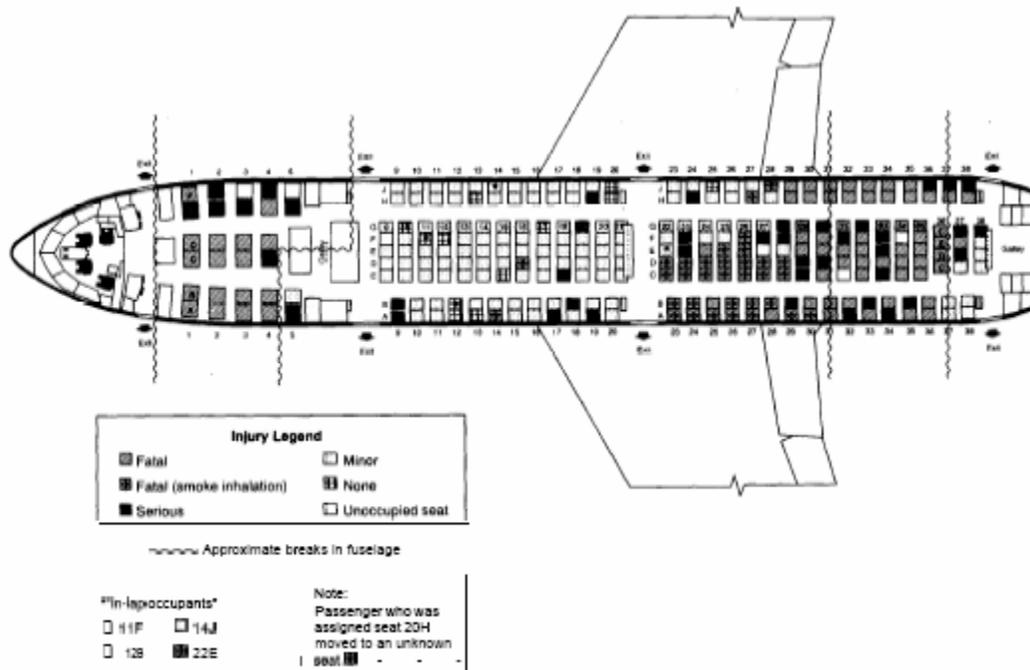
Of the 296 people onboard, 111 died and 185 survived (see Figure 1). Of the 185, forty-seven were seriously injured, 125 had minor injuries, and 13 reported no injuries. Passenger seating was provided in 38 rows in this configuration of a DC-10. The setup was typical with the first class section taking up rows 1-8 and coach seating (2/5/2 seat arrangement per row) in the remainder. The upside-down center section in the cornfield contained rows 9-30, which was where most of the surviving occupants of the aircraft were seated. It therefore made sense to focus firefighting efforts to this area. Although this portion of the aircraft was eventually destroyed by fire, the early fire suppression activities are credited with saving many lives. Thirty-three of the 35 passengers, who died from asphyxia/smoke inhalation, were in rows 22-30. The egress path was to the front of the wreckage and these 35 people were seated in the back. Twenty-four of them did not receive traumatic blunt force injuries and may have been overcome by the smoke before they had a chance to reach the opening in the front. Also contributing to the high survival rate was “brace-for-impact” instructions given by the flight attendants.

Figure 1 Aircraft Configuration and Occupant Injuries, Flight 232
(Copied from NTSB Accident Investigation Report)

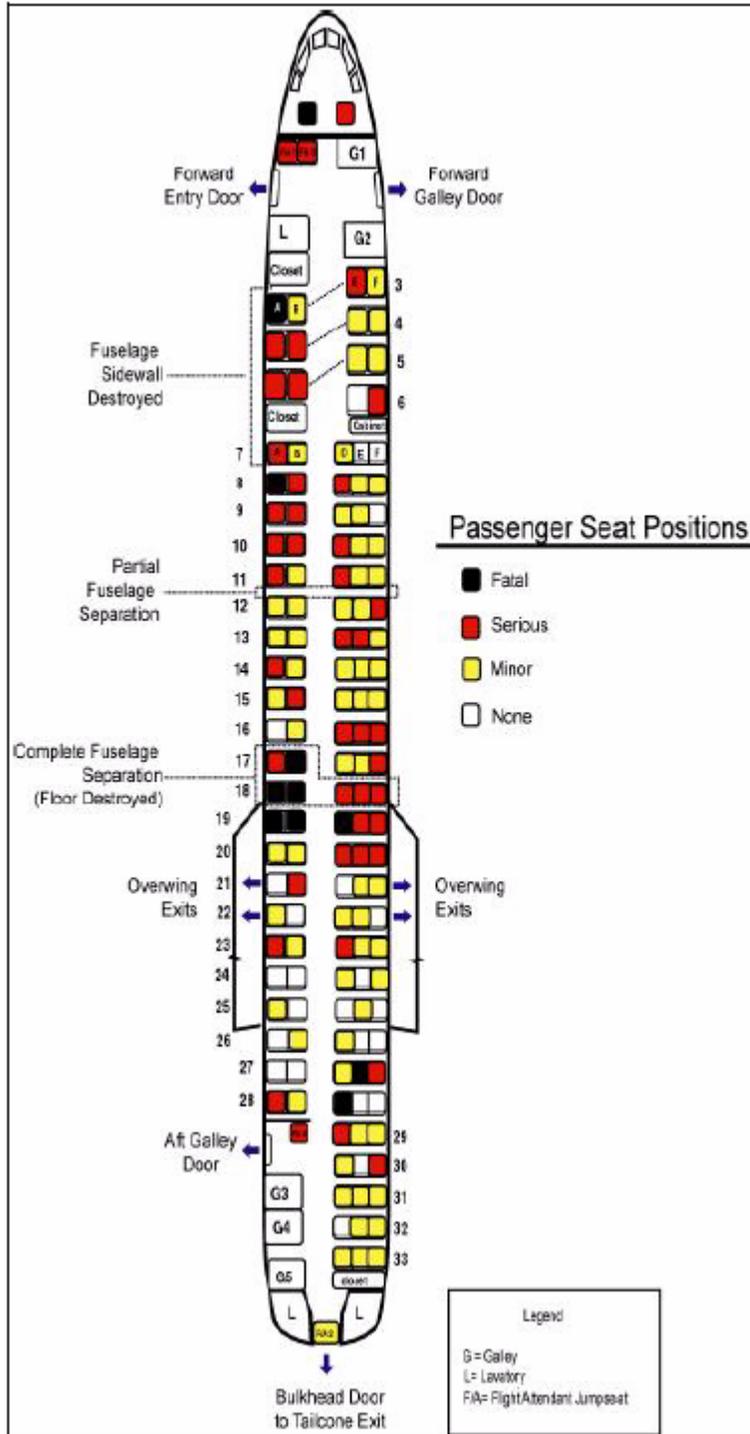
The Pilot was killed on impact with the ALS. There were 10 other fatalities. Passengers in 3A, 8A, 17B, 18A, and 18B died of traumatic injuries. Five passengers in 19A, 19B, 19D, 27E, and 28D died of asphyxia/smoke inhalation. Three of these passengers were at the opening where there fire entered the rear section of the cabin. The two other smoke inhalation fatalities were quite a ways back in the cabin and further analysis would need to be conducted to determine if age or other factors contributed to their inability to self evacuate. Figure 2 shows the relationship to the fatalities and the break points on the aircraft. Passengers in first class in 3A, 3B, 4A, 4B, 5A, and 5B were ejected from the aircraft while still strapped in their seats. Also at the center section break, passengers in 17A, 17B, 18A, 18B, 18D, 18E, and 18F were ejected from the aircraft while still strapped in their seats. Comparing those that died with those that were ejected, four of the 13 passengers ejected from the aircraft died of traumatic blunt injuries, the others that were ejected, survived.

Figure 2 Aircraft Configuration and Occupant Injuries, Flight 1420
(Copied from NTSB Accident Investigation Report)
