NATIONAL TRANSPORTATION SAFETY BOARD

SURVIVAL FACTORS/AIRPORT AND EMERGENCY RESPONSE GROUP CHAIRMAN'S
FACTUAL REPORT

On February 7, 2006, at 2359 eastern standard time, a Douglas DC-8-71F, N748UP, operated by United Parcel Service Company (UPS) as flight 1307, landed at Philadelphia International Airport (PHL), Philadelphia, Pennsylvania, after the crew reported a cargo smoke indication. The three flight crewmembers were able to evacuate the airplane using the L1 slide. Fire subsequently caused substantial damage to the airplane and numerous cargo containers on board. The three crewmembers received minor injuries. Night visual meteorological conditions prevailed and an instrument flight rules flight plan had been filed for the flight from Hartsfield-Jackson Atlanta International Airport (ATL), Atlanta, Georgia, to PHL. The scheduled cargo flight was conducted under 14 CFR Part 121.

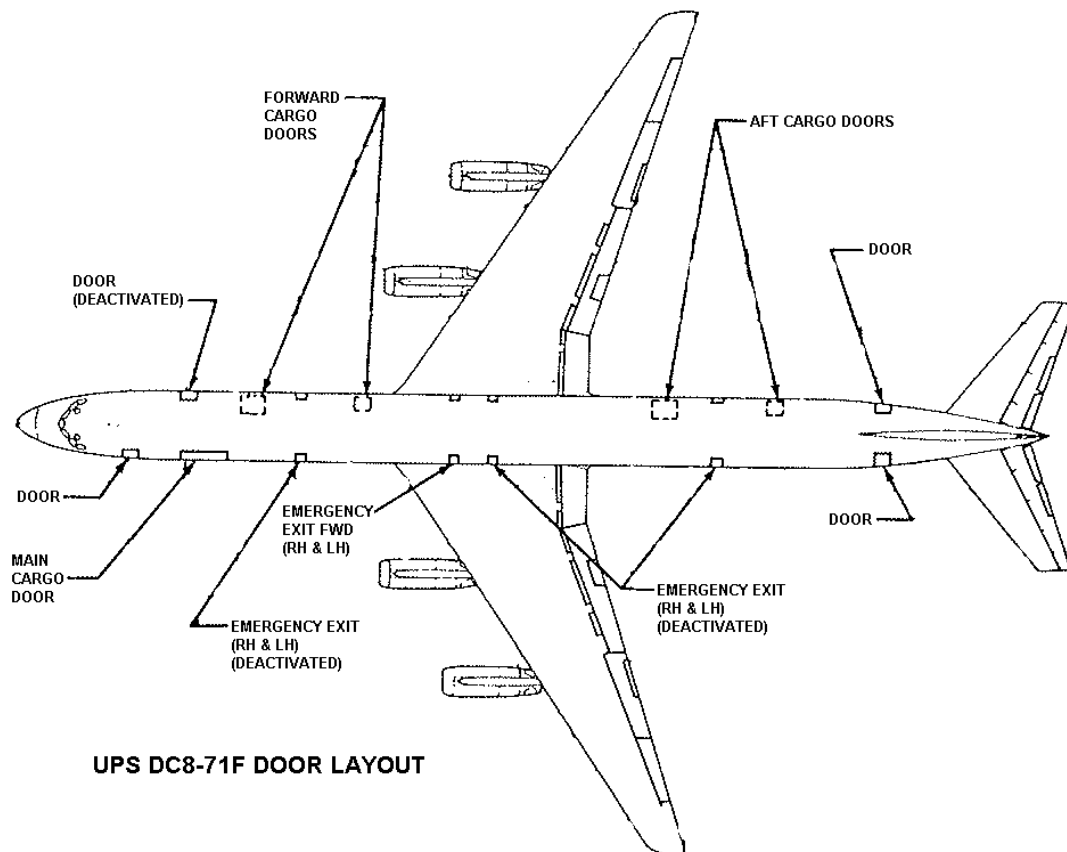
The airplane cabin was a cargo-class configuration with 3 floor-level door exits and one over-wing window exit on each side of the airplane.

See Attachment 1, *Interior Arrangements for UPS DC-8 Cargo Airplane*, dated February 13, 2006, for the airplane configuration of N748UP.
